Test Report T68-4-1

METALLURGICAL ANALYSIS OF 5.56mm BULLET, COPPER
PLATED-LEAD CORED

October 1967

QUALITY ASSURANCE DIRECTORATE FRANKFORD ARSENAL PHILADELPHIA, PA. 19137

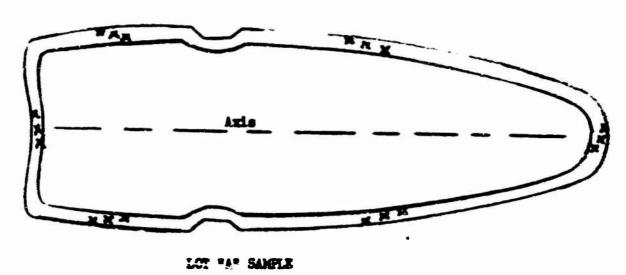
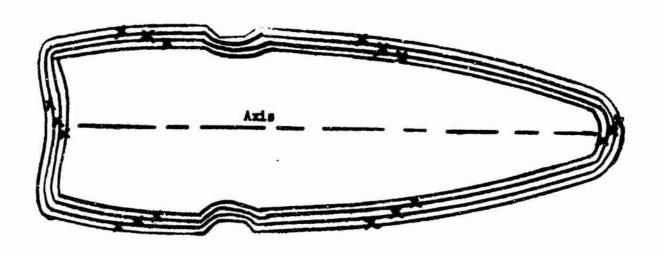
Figure 6. Location of hardness indentations in test bullets of lots A & B.

In Lct A (see Figure 6 and Table I), the readings obtained perpendicular to the axis indicated that adjacent to the outer surface along the copper jacket, the base of the bullet was much softer (RB 26) than the nose (RB 60) or sidewalls (RB 57 and 54). The same betrvior pattern was noted in the middle sector of the jacket, but with hardness values increasing somewhat to RB 50 at the base, RB 62 at the nose and RB 61 and 59 at the sidewalls. The inmost readings were comparable to the middle sector results, the base measuring RB 53 and the nose and sidewalls RB 61 and RB 60.

In Lot B (see Figure 6 and Table I), the outer layer was harder at the nose (RB 84) and base (RB 84) than at the sidewalls (RB 78). In the middle layer, the base (RB 77) and nose (RB 78) were harder than the sidewalls (RB 70 and 71). The inmost layer was harder at the nose (RB 70) and base (RB 72) than locations along the sidewalls (RB 57 and 56).

The hardness of Lot A transverse to the bullet axis (see Figure 6 and Table I) as compared to the hardness parallel to the axis (see Figure 7 and Table II) showed that a difference in hardness existed at the sidewall section between the nose and cannelure, the average transverse hardness being RB 59, while the parallel direction hardnesses averaged RB 50. The direction of indent did not appear to have any effect on hardness at other locations of the bullet jacket.

The hardness results of Lot B transverse to the bullet axis (see Figure 6 and Table I) versus results parallel to the axis (see Figure 7 and Table II) showed direction of indent had practically no effect on the hardness results of the sidewalls, that is, there was little difference due to direction of testing.

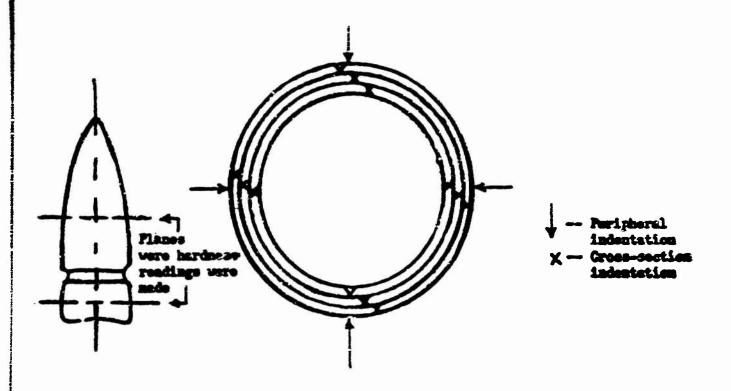
Figure 7. Location of hardness indentations in the copper jacket longitudinal to the bullet axis and peripherally on the surface.

Results of hardness tests in the copper jacket, parallel to the bullet axis in Lot A (see Figure 7 and Table II), showed very slight differences in hardness from the outer sector inward to the substrate either at the sidewall or nose areas. The sidewall from nose to cannelure was in the range RB 49-51 and from cannelure to base RB 54-58. The average hardnesses at the different locations along the bullet did vary somewhat, however, the sidewalls in front and behind the cannelure averaging RB 50 and RB 56, respectively.

In Lot B (see Figure 7 and Table II), the results parallel to the axis showed that at the sidewalls and nose, there existed a definite hardness gradient from a harder outer sector inward to a softer area immediately adjacent to the lead substrate. The sidewall between the nose and cannelure varied from RB 83 to RB 58, while the sidewall between the cannelure and base varied from RB 80 to RB 65. The hardness gradient in the latter location is illustrated in Figure 8. The size of each hardness indentation is shown increasing from the surface inward. The average bardness, however, at the different locations varied only slightly, the sidewall values averaging RB 71 and RB 73.

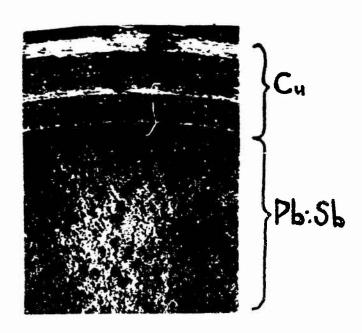
The hardness survey showed that copper plating in Lot B was much harder than that of Lot A. The hardness pattern of the three layers of Lot B, wherein a hardness gradient existed, that is, the layers becoming gradually softer inward to the core, was believed to be attributable to variation in the current density in depositing each layer, the outer layer having a relatively higher current density and then the inner layers progressively less. Of course, other conditions such as bath temperature and addition agents might have affected this hardness behavior also. The hardness behavior of Lot B was nevertheless different from that of Lot A when considering the similarity in locations of hardness impressions. The readings in Lot A showed little variation from the surface inward to the core (base excluded). The peripheral hardness of Lot A was relatively high, however, a condition which probably resulted from the finishing operation.

Figure 8. Hardness gradient in 0.014 in, thick copper jacket of 5,56 mm lead cored buller of Lot B shown by increasing size of Vickers hardness indentations from outer surface towards Pb:Sb core.

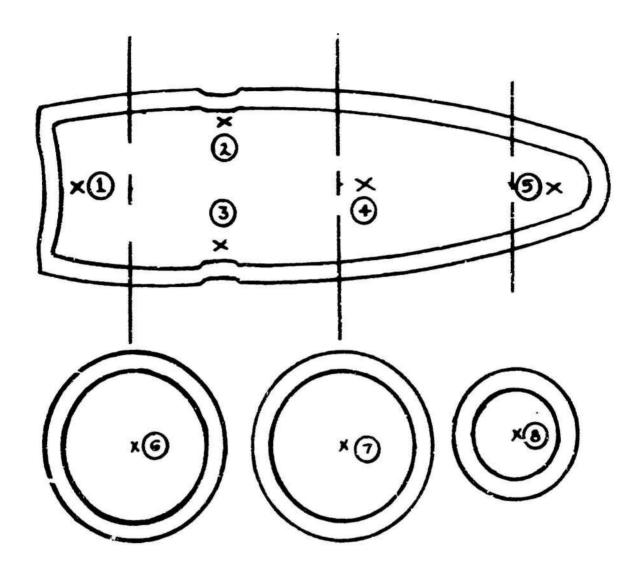
Figure 9. Locations of hardness impressions in lead-antimony core designated by "X". The impressions are perpendicular (Nos. 1 to 5) and longitudinal (Nos. 6 to 8) to the bullet axis.

In comparing the hardness of Lots A and B (see Figure 9 and Table III), Lot B core was generally harder than the Lot A core. The hardness of the core centers, however, according to impression Nos. 4 and 7 in each lot, coincided in both perpendicular and longitudinal directions to the bullet axis, the Brinell hardness values (BHN) averaging 7.1 and 6.3, respectively. It should be noted that these impressions were located away from the copper jacket in a region where the effects of any strain hardening would be minimal, e.g., strain hardening that might result in resizing of the bullet.

Impressions numbered 2 and 3 (see Figure 9 and Table III) in each lot which were located immediately under the cannelure exhibited somewhat higher hardnesses than the other impressions in each respective lot.

Impressions Nos. 1 and 5 in Lot A compared closely to the hardness at the core center. The averages were BHN 6.9 and 7.5 to BHN 7.1 at the center. In Lot B, Nos. 1 and 5 were higher than the core center hardness of BHN 7.1, averaging BHN 7.9 and 8.2, respectively.

The hardness results obtained in the lead cores of both lots showed the areas immediately below the cannelure to be harder than the other locations within the core. This condition was undoubtedly due to work hardening imparted to the lead substrate in these areas during the forming of the cannelure groove. It was noted that the hardness impressions furthest from the surface located midway along the bullet axis were softer than the other impressions. There was an exception in Lot A where impressions near the base corresponded to the core center hardness.
